**MHTG/TGU**  
**TONCONTIN INTL**

**JEPPESEN**  
 16 MAY 08 **19-01**

**AIRPORT QUALIFICATION**  
**TEGUCIGALPA, HONDURAS**

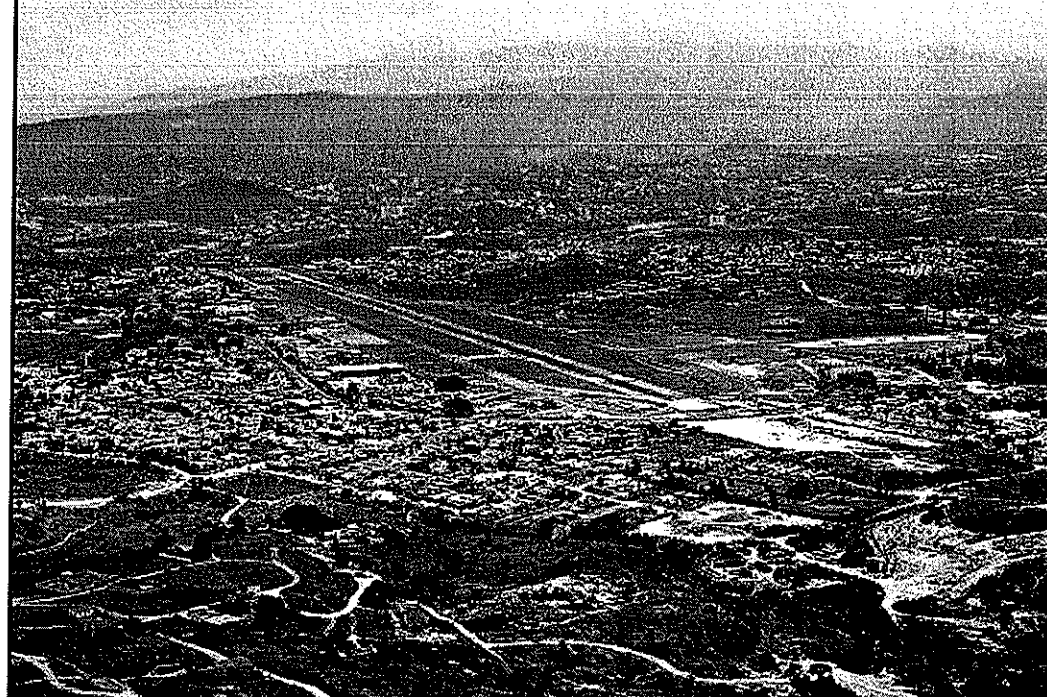
**OVERVIEW**

Public	Longest Rwy (LDA): Rwy 20 - 6109' (1862m)		Time Conv (Std): UTC -6	
<b>OVERVIEW</b>				
<p>Toncontin International Airport is located in south central Honduras in a small mountain valley and is surrounded by high terrain. The airport is near the Couluteca River and the mountains defining the valley are mostly volcanic in origin. Lower terrain is to the north along the narrow floor while the peaks on both sides of the valley commonly rise between 5000 and 7500 feet MSL. To the east, terrain rises to 6581 feet MSL within 9 NM. To the west, terrain rises to 5827 feet MSL within 5 NM. The Pacific Ocean is about 50 NM to the south while the Caribbean coastline is about 100 NM to the north.</p> <p>There are no straight-in instrument approach procedures for this airport.</p> <p>Circling to land is not authorized east of the runway.</p> <p>Prohibited Area MH(P)-1 is adjacent to the runway, all traffic should remain west of the runway to avoid this area.</p> <p>The higher landing minimums and special missed approach procedures are designed to allow for clearance of high terrain near the airport.</p>
